Variable Frequency Drives

Edward R. Estberg

FMI Energy Conference

Raley's Compressor Test

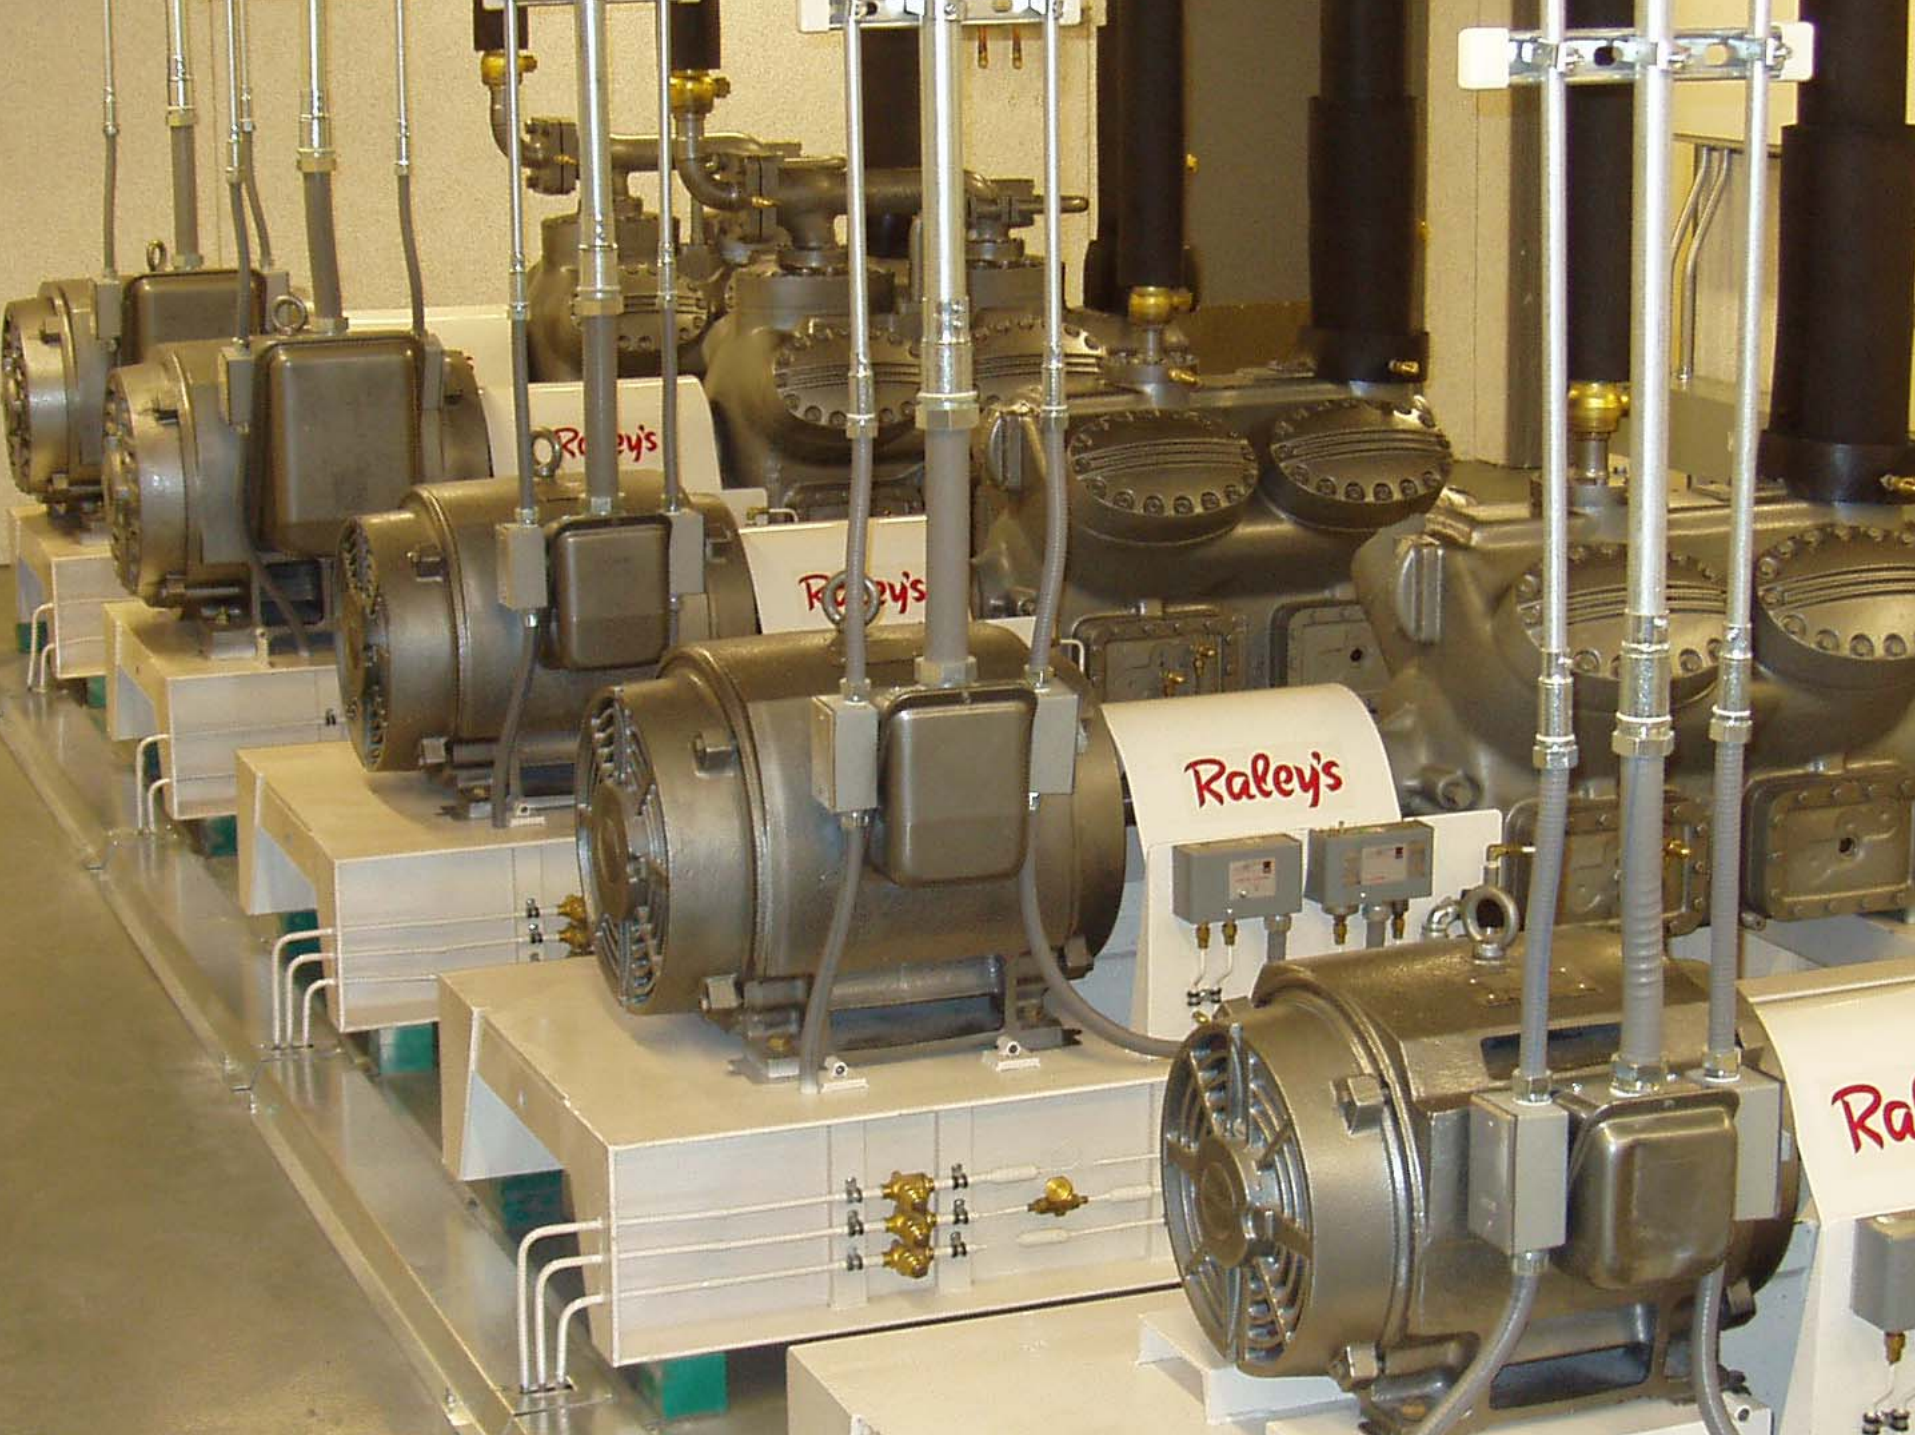
- Added VFD's to all six compressors
- Existing store with a full year of history
- No other major changes to the refrigeration system
- Purpose was to solve starting problem and to save energy.

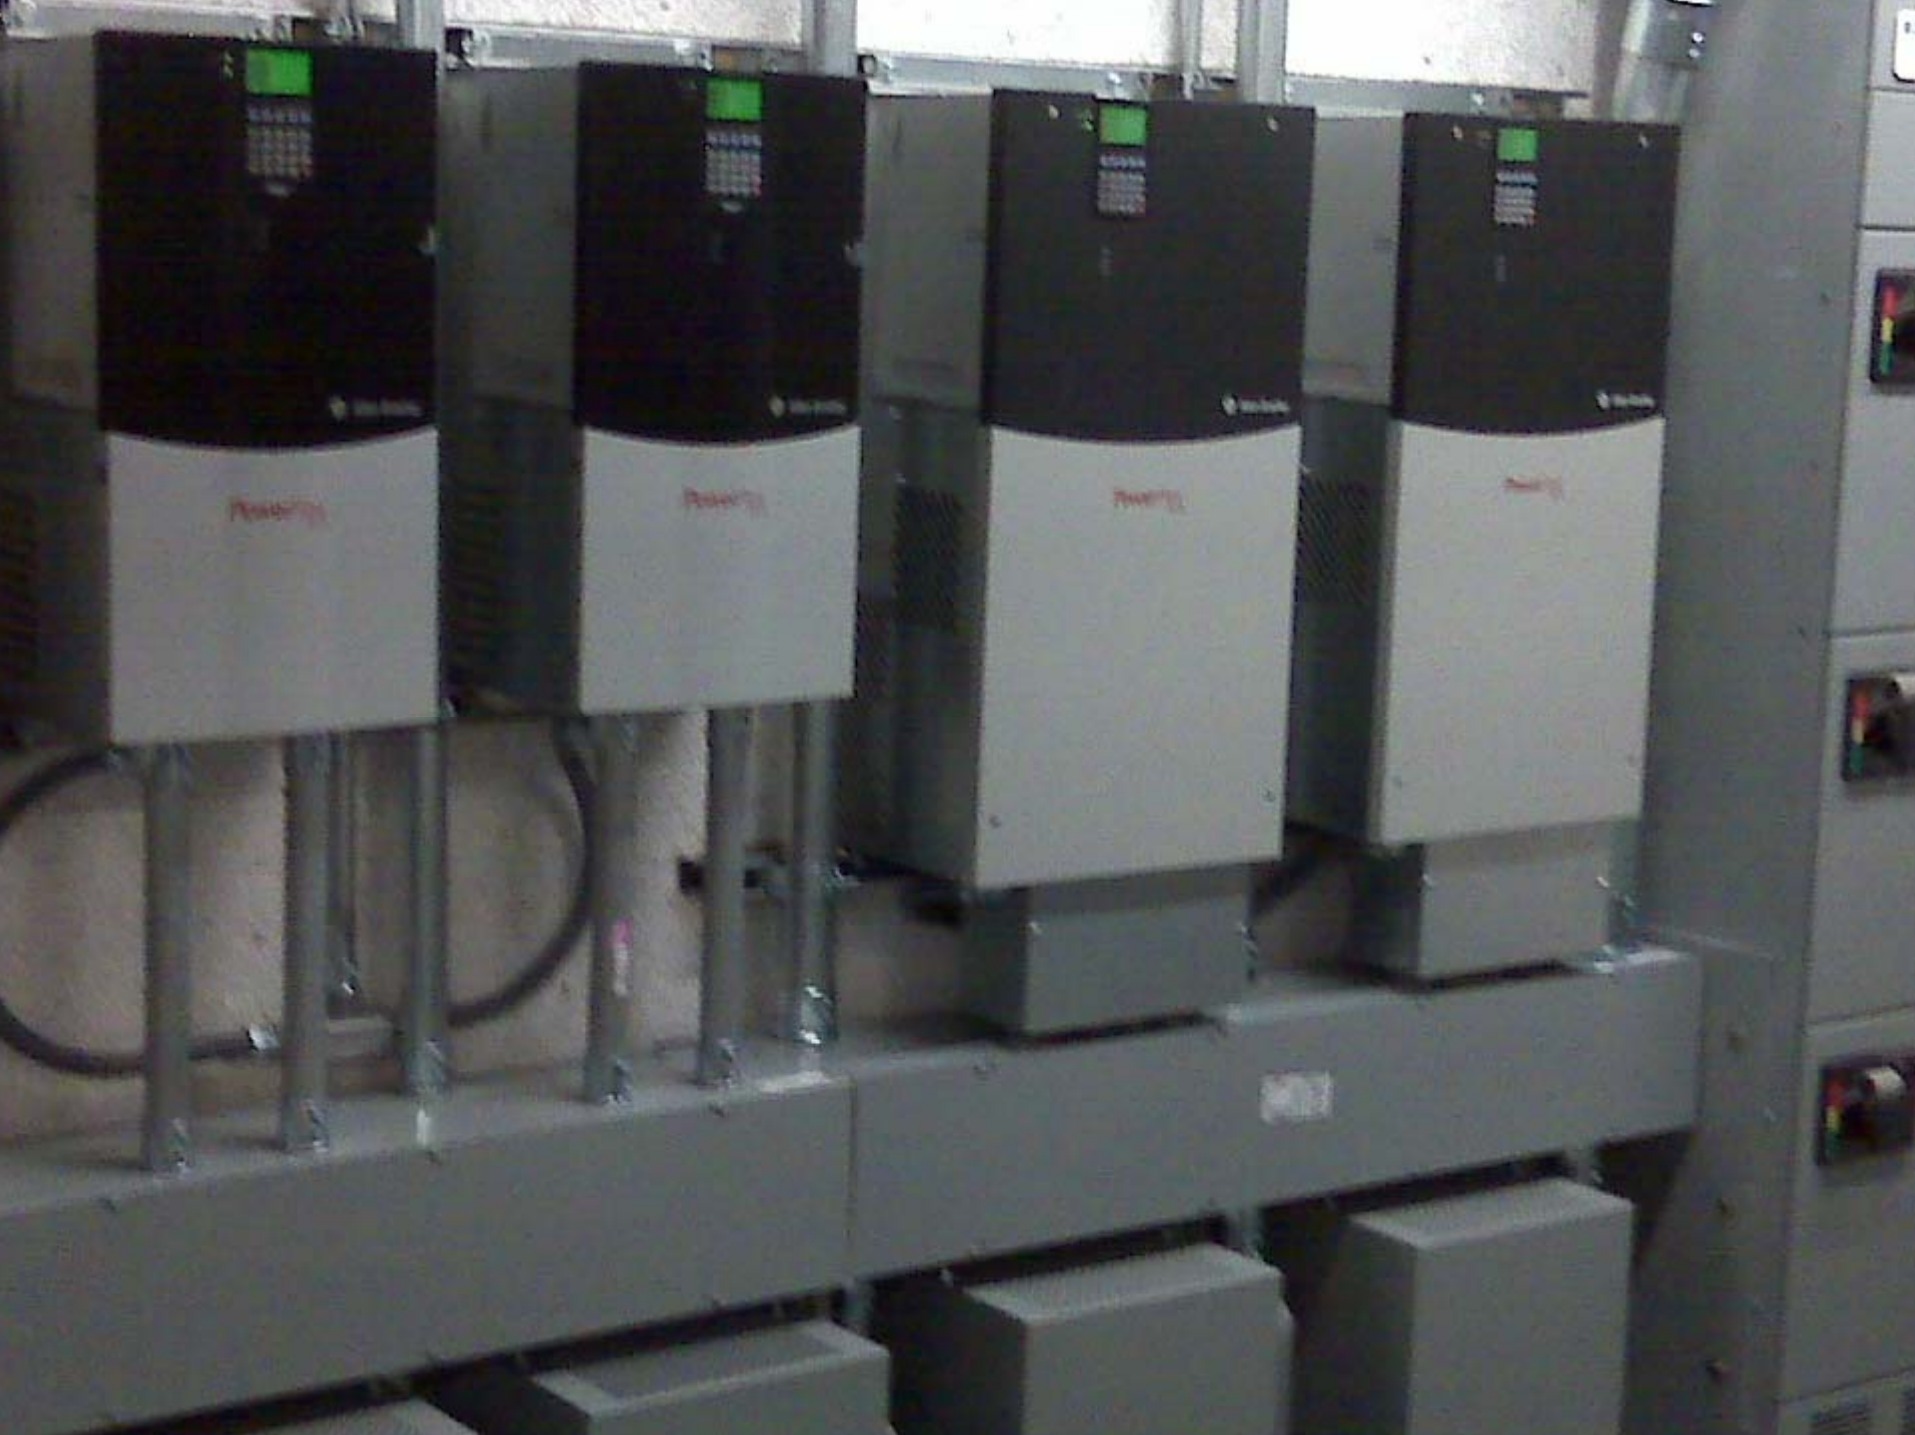
- Solved our starting problem
- Reduced energy by about 2%
- Reduced cycling
- Stabilized suction pressure
